Final Report  
for the period  
October 1983 to  
March 1984

## **Columbium Chamber Fabrication Study**

Author:  
V. Frick

Aerojet Tech Systems Company  
P. O. Box 13222  
Sacramento, CA 95813

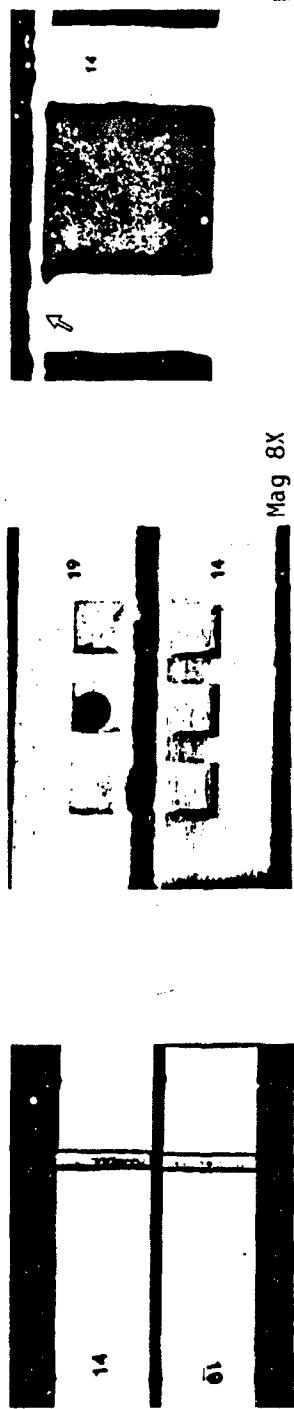
Panels 14 (iron) and 19 (molybdenum) were sectioned, after columbium deposition, as shown in Figure 14. The top views show a flat, relatively even, deposit of columbium, .35 mm (0.014 inches) thick, over the channels. Somewhat greater shrinkage than that seen for the "as-sintered" condition shown in Figure 13 is apparent. In fact, the lower right photomicrograph shows an agglomerated porous iron structure indicative of temperature exposure in excess of the 1150°C (2102°F) sinter temperature.

Panel 14 - 094 Channels Iron Contamination on Land (Arrow)

Panel 14 - Agglomerated Sintered Iron Indicates > 1150°C Exposure.

Contamination in the bond interface (arrows in the views in Figure 14) degraded the bond quality of the columbium deposit to the C103 substrate. Great care was taken to finish the land preparation in the direction of the lands and cotton swab the area with acetone. Still, the cause of the contamination could be due to smearing of the iron across the lands when dressing down the surface. Later in the program, another potential cause of iron contamination was hypothesized. The free energy of formation may favor the formation of  $\text{FeCl}_2$  from  $\text{CbCl}_5$  vapor in contact with the iron, and subsequent reduction of  $\text{FeCl}_2$  may result in a deposit of iron on the lands. This is discussed in some detail below.

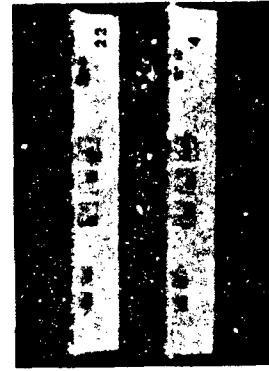
Figure 17. CVD Run 3 - Al1 Iron Filled Panels Melted  
(Nos. 23, 24, 26, and 27 Shown). Panels No. 4  
and 22 Contained Molybdenum.

reported temperature of 1150°C (2102°F), lasted for 105 minutes before depletion of columbium in the chlorination chamber. After cool down, the melting was noted and the run discontinued. The condition of six of the eight panels is shown in Figure 17. Only the molybdenum containing Panels Nos. 4 and 22, remained intact.

The molybdenum filled panels, Nos. 4 and 22, represented two additional attempts to create cavities within the molded molybdenum powder. Although the cotton corded left reasonably large cavities, neither they nor the smaller molybdenum tubes provided any significant improvement in removal of the molybdenum. The overall condition is similar to that found for the molybdenum containing panels of the second carousel run.
